MARKED WEAR ON THE PLAIN BEARING OF A FRANCIS TURBINE - A POTENTIAL ALIGNMENT ISSUE?

An interesting assignment presented itself to the Service Team of PRÜFTECHNIK Alignment Systems in a high-head hydropower plant on the river Isar. Marked bearing damage had been identified in a Francis turbine and its associated generator and PRÜFTECHNIK was appointed with the task of identifying the root cause.

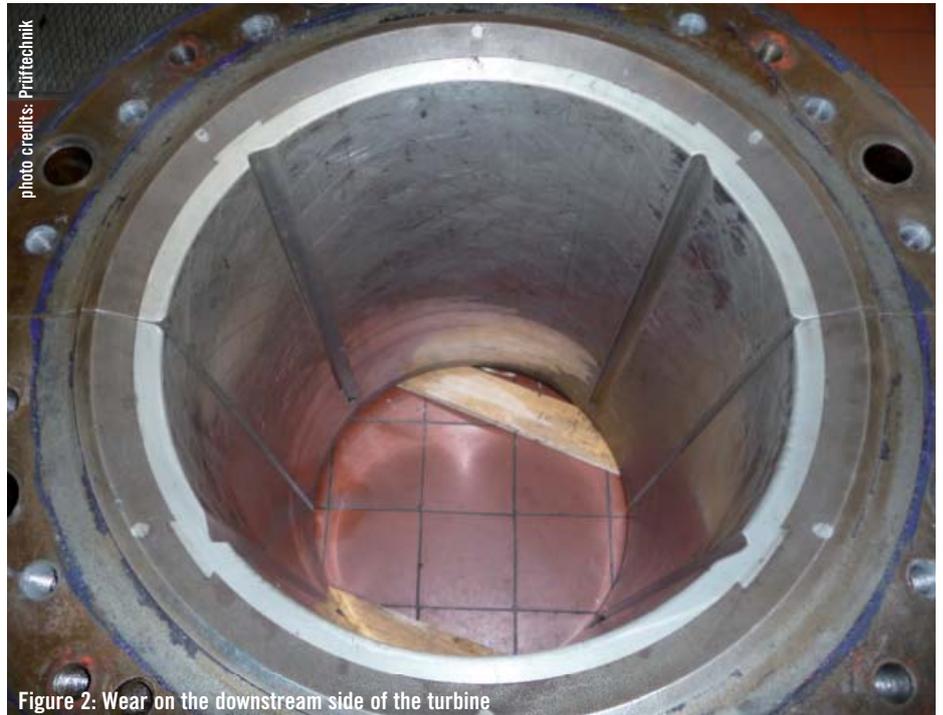
During the course of a scheduled overhaul, atypical uneven wear was discovered on the plain bearing of the Francis turbine and the lower plain bearing of the generator. The wear on the generator bearing occurred on the upstream side and that on the turbine (Figure 2) on the downstream side. The op-

Figure 2: Wear on the downstream side of the turbine

erator's overhaul team therefore conducted a plumb line test on the plain bearing from the upper side of the generator. This indicated an apparent 2-mm downstream misalignment of the bearings. The power plant operator contacted PRÜFTECHNIK Alignment Systems to perform a laser measurement to confirm the results of the plumb line test. The Service Team of PRÜFTECHNIK carried out the measurement in two stages.

The lower generator bearing was corrected by 0.3 mm on the upstream side and the upper axial support bearing was levelled slightly by 2/10 mm.

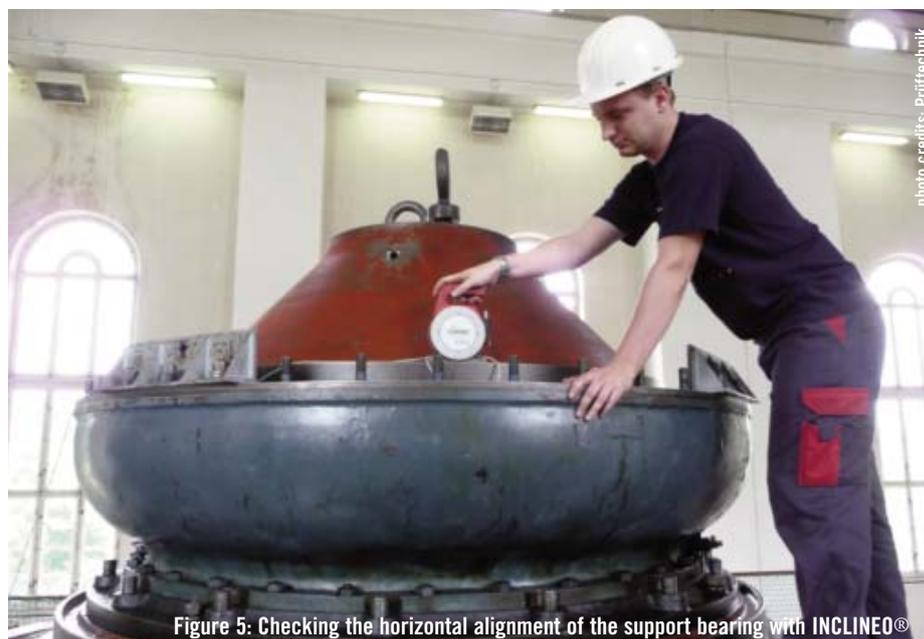
In the second stage of the measurement process, the Service Team of PRÜFTECHNIK checked the level using a high-precision INCLINEO® angle measurement system (Figure 5). INCLINEO® is capable of measuring both absolute (i.e. "under water") and relative surfaces - and it can do this with the rotating measuring cell in either a horizontal or a vertical position. The upper axial support bearing flange was used to determine whether it was level and flat. Although the flange itself was relatively level, it did exhibit an inclination of 2/10 mm on the upstream side of a flange diameter of 1.6 m.

Figure 5: Checking the horizontal alignment of the support bearing with INCLINEO®
