MARKED WEAR ON THE PLAIN BEARING OF A FRANCIS TURBINE - A POTENTIAL ALIGNMENT ISSUE?

An interesting assignment presented itself to the Service Team of PRÜFTECHNIK Alignment Systems in a high-head hydropower plant on the river Isar. Marked bearing damage had been identified in a Francis turbine and its associated generator and PRÜFTECHNIK was appointed with the task of identifying the root cause.

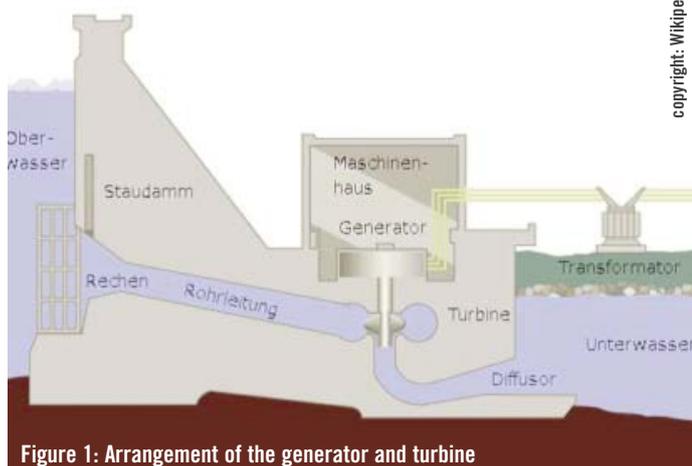
Figure 1: Arrangement of the generator and turbine

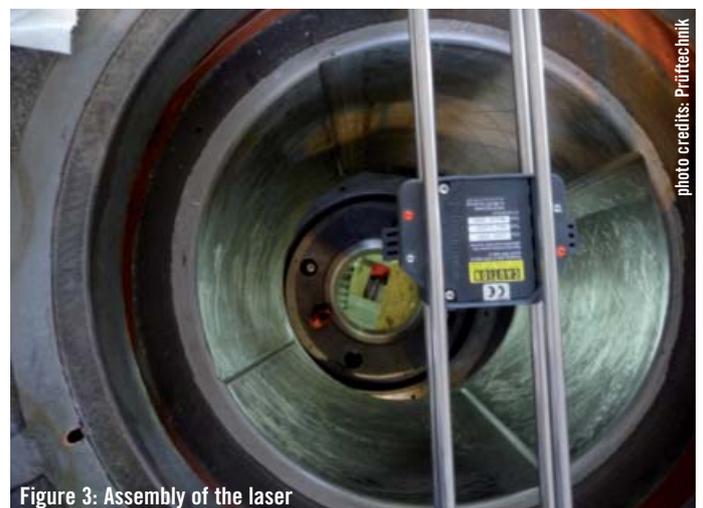
First, the system's laser was mounted on the upper generator bearing using a magnetic holder (Figure 3). The counter piece to the laser is the sensor. Mounted on a pointed bracket, it was clamped in place using a special quick-assembly holder in the plain bearing being measured in a way that allowed it to be rotated (Figure 4).

Figure 3: Assembly of the laser

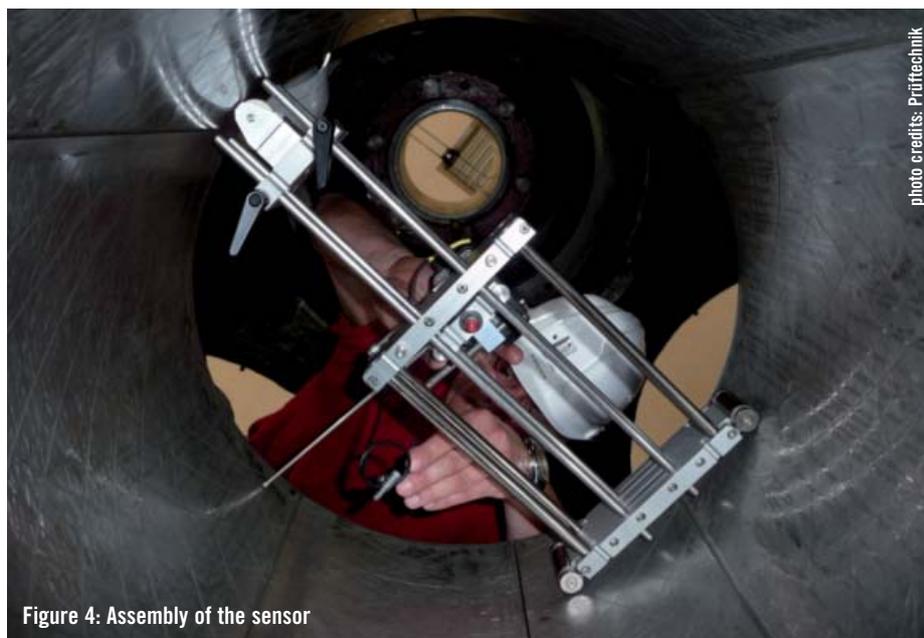
Figure 4: Assembly of the sensor

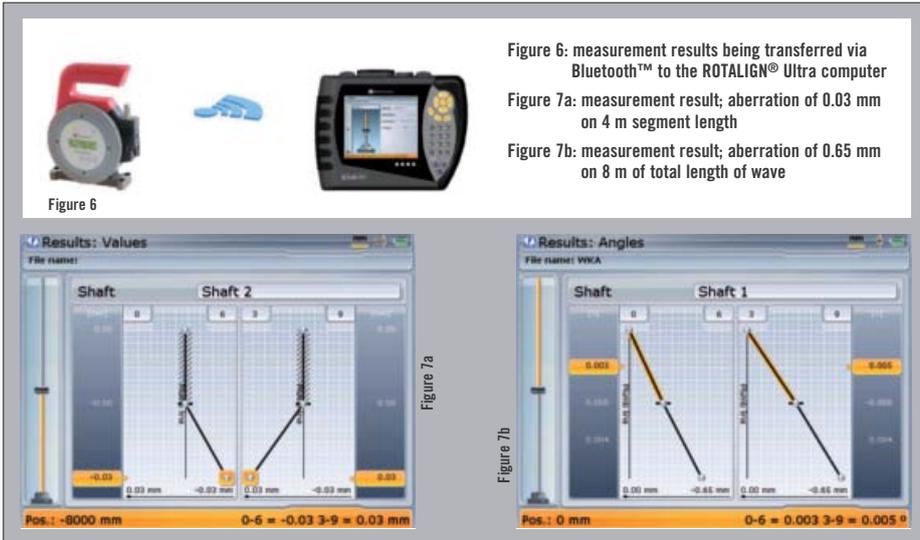
Figure 6: measurement results being transferred via Bluetooth™ to the ROTALIGN® Ultra computer

magnetic base. Two circular measurements were taken for each shaft segment in order to check the reproducibility of the measurements. The final step deals with the measurement results. (Figure 6) ROTALIGN® Ultra Hydropower showed that the position of the shaft segments exhibited a difference of only 3/100 over a segment length of 4 metres (Figure 7a); a very low value. This proves that the bearings are now very well positioned. Examining the perpendicular gives an offset of 0.65 mm along the entire 8-metre length of the shaft downstream (Figure 7b) and to the west. If required, the perpendicular alignment of the shafting could be improved by adjusting it on the upper thrust bearing. However, according to the operator, this value does not affect the operation of the turbine; rather it is the alignment of the two shaft segments which has the most significance. The shafting itself and the bearing alignment are accurate and very well aligned to one another. The bearing damage on the lower generator and turbine bearing is now a thing of the past. With the new ROTALIGN® Ultra Hydropower the user now has a high-precision, high-speed measurement system capable of determining the relative position of vertical shafts and ensuring they are perpendicular without using the line of sight.
